# VOLCANIC ASHFALL

## ADVICE FOR: POWER PLANT OPERATORS

### ASH IMPACTS ON POWER GENERATION FACILITIES

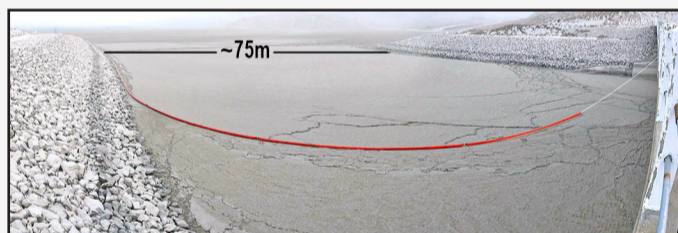
Pumice raft from the June 2011 eruption of Cordón Caulle volcano, Chile, on the Alicura HEP reservoir. Dam staff had advance warning of the arrival of the pumice raft (of 6 million m<sup>3</sup> volume) and used oil spill booms to attempt to direct the pumice away from intakes. Photo by AES Argentina.

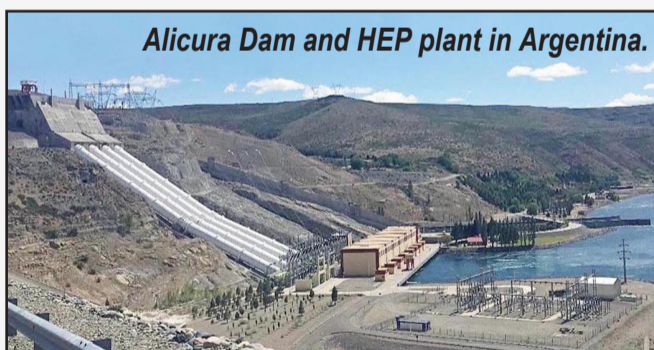
Alicura Dam and HEP plant in Argentina.

While the HEP plant maintained power generation at full capacity, a range of problems was experienced. Staff access to the dam site was disrupted by extensive ashfall across road networks, and reduced visibility during wind remobilization events. Cleaning of the site took around four months and had a high labor demand. Air intake filters were clogged with ash and had to be replaced much more frequently. Floodgates clogged by ash could not open. Corrosion was also an issue; every unpainted/ungalvanized metal surface was affected which shortened the working life of components. Photo by Gustavo Villarosa.

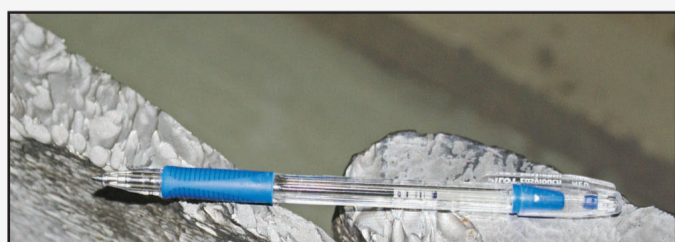
Accelerated abrasion damage to wicket gates from Agoyan HEP, Ecuador. Normal design life of turbines at this plant is 6-7 years, but this has been reduced to 5 years due to ashfalls from nearby Tungurahua volcano contaminating reservoir water. Photo by Johnny Wardman.
