ADVICE FOR POWER PLANT OPERATORS

IMPACTS ON POWER GENERATION FACILITIES

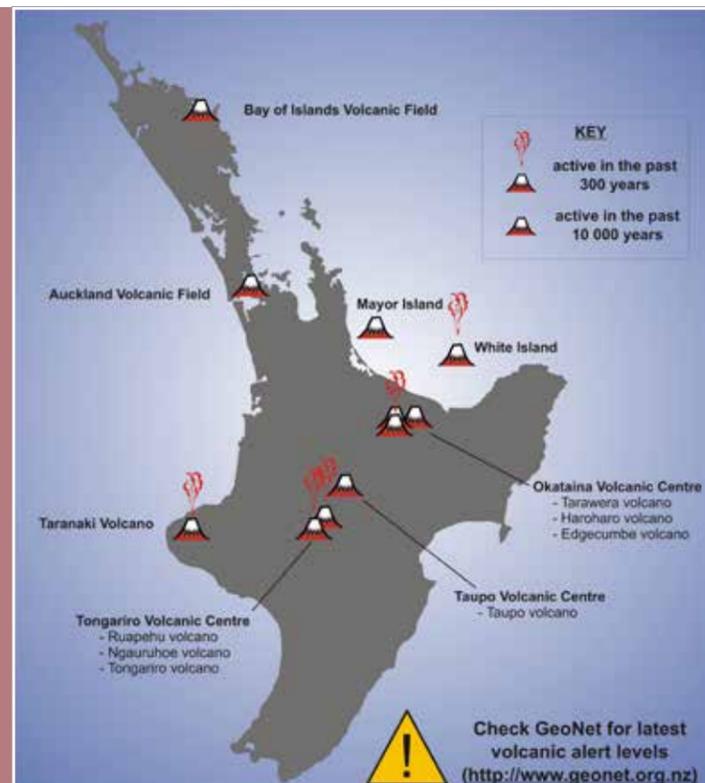
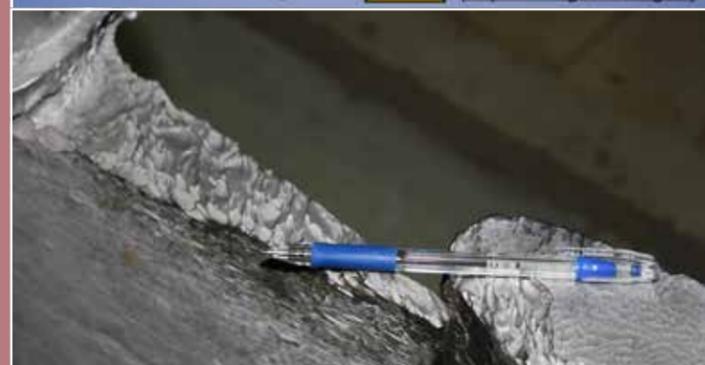
Accelerated abrasion damage to wicket gates from Agoyan HEP, Ecuador. Normal design life of turbines at this plant is 6-7 years, but this has been reduced to 5 years due to ashfalls from nearby Tungurahua volcano contaminating reservoir water.

- Ash suspended in intake water can cause accelerated wear of hydroelectric turbines (e.g. runner blades, labyrinth seals, cheek plates and wicket gates)
 - » Hazard depends on volume of ash deposited in catchment, reservoir size, settling rate of ash, abrasiveness of ash
- Ash may also fill rain gauges in climate stations throughout river and reservoir catchments.

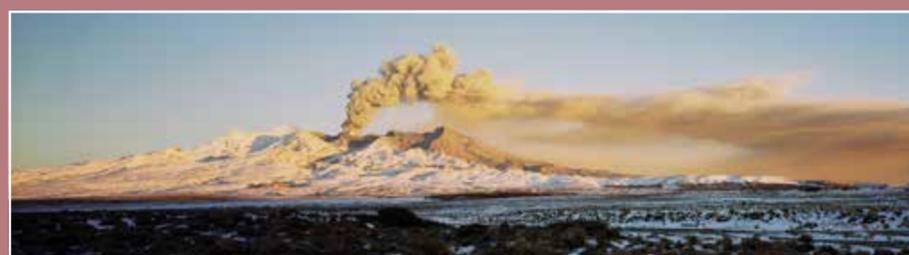
The October 1995 eruptions of Ruapehu volcano deposited 7.6 million m^3 of coarse ash into the Tongariro river catchment, leading to high levels of suspended ash. This catchment feeds the Rangipo power station (120 MW). While generation remained continuous throughout the eruption, two Francis turbines and all auxiliary components that had been in contact with ash-laden intake water were found to have suffered greatly accelerated abrasion damage, with 16 years' damage sustained in 6-7 months. A refurbishment program installed hardened components. Turbidity instrumentation was also installed at the intake point which is closed when thresholds are exceeded.
