VOLCANIC ASHFALL

ADVICE FOR: AIRPORT OPERATORS

ASH IMPACTS ON AIRPORTS

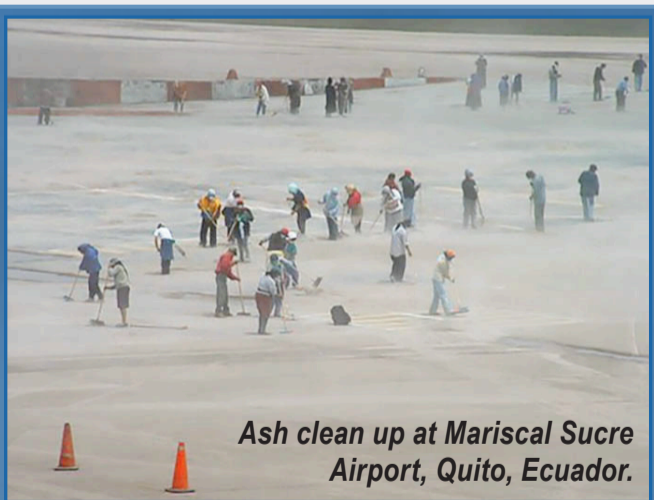
It took 500 people at least 7 days to clear ash from the airfield using brooms when 4 mm (0.2 in) ash accumulated following the 2002 eruption of Reventador volcano. Photo by Mariscal Sucre Airport, Ecuador.

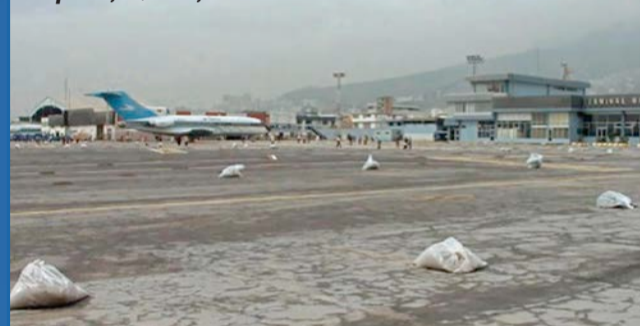
Bagged ash at Mariscal Sucre Airport, Quito, Ecuador.

Ash was bagged in place then removed by truck when 4 mm (0.2 in) ash accumulated following the 2002 eruption of Reventador volcano. Photo by Mariscal Sucre Airport, Ecuador.

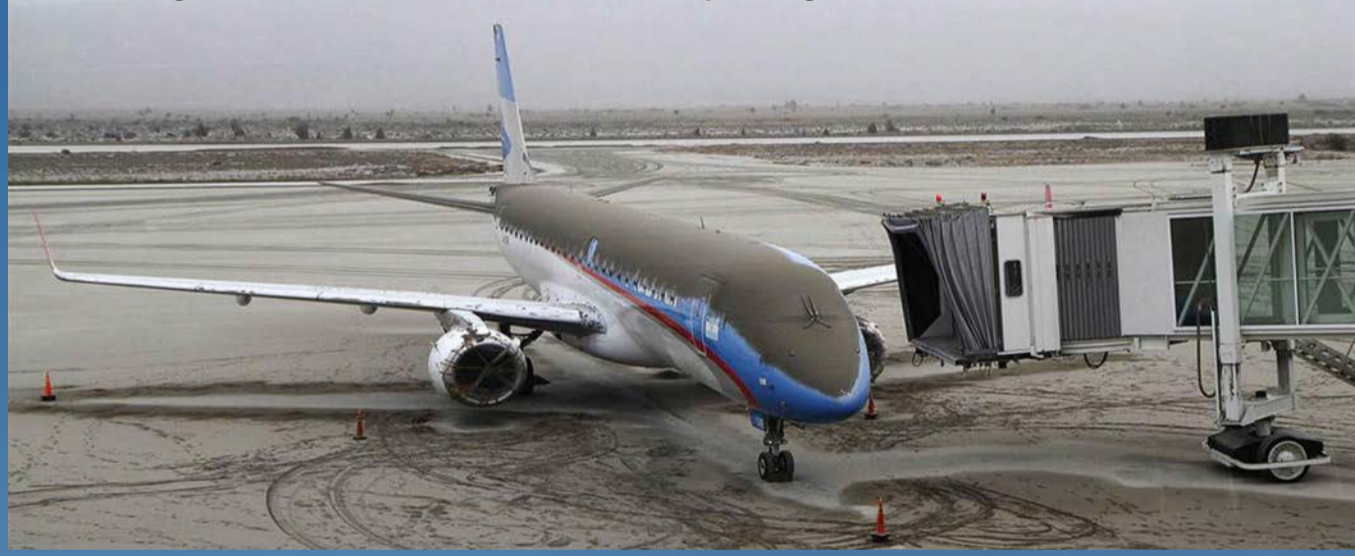
Ash covering San Carlos de Bariloche International Airport, Argentina.

The airport was closed for 1 month when 25 mm (1 in) of ash accumulated on the airfield following the 2011 eruption of Cordón Caulle volcano in Chile. Extra volumes of antifreeze were required to remove ice contaminated with ash. 1000 tons of ash were removed and distributed in the immediate area. The ash was stabilized using irrigation systems to encourage grass growth. Photo by Bariloche International Airport, Argentina.
